## Inspection Report

### **Absolute Home Solutions**

123 Sandy Beach  
Anytown Fl 33333

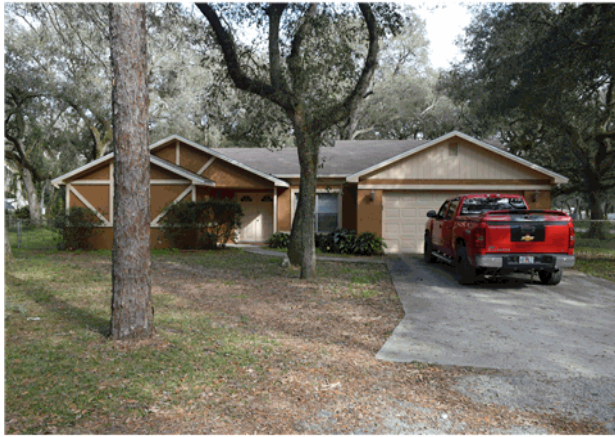
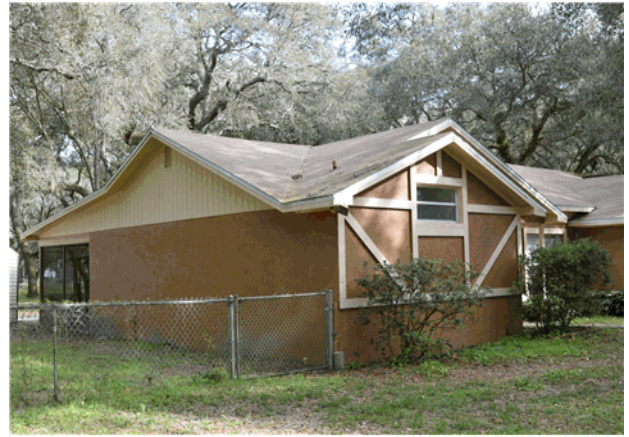
##### 1) Grading Conditions

The soil level was too high at the foundation. We recommend clearing soil away from exterior walls areas, to provide a minimum of 6+ inches between wall coverings and grade. Conditions observed are conducive to wood destroying insect infestation and / or moisture related conditions. At minimum it is recommended that a gutter system be installed to divert water away form foundation.

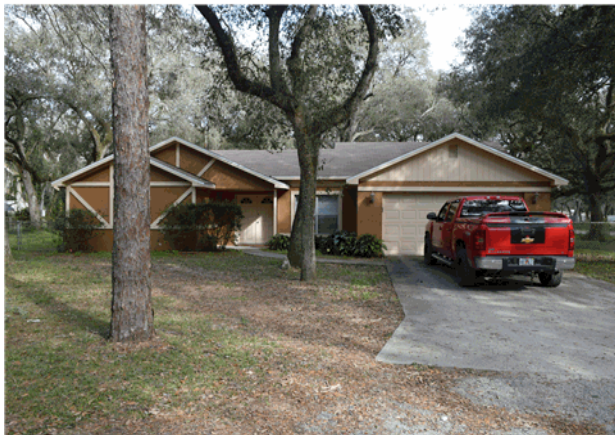
##### 2) Driveway Conditions

The driveway appeared to be in serviceable condition at the time of the inspection. Common cracks and settlement were observed. The driveway has some surface erosion and minor deterioration.

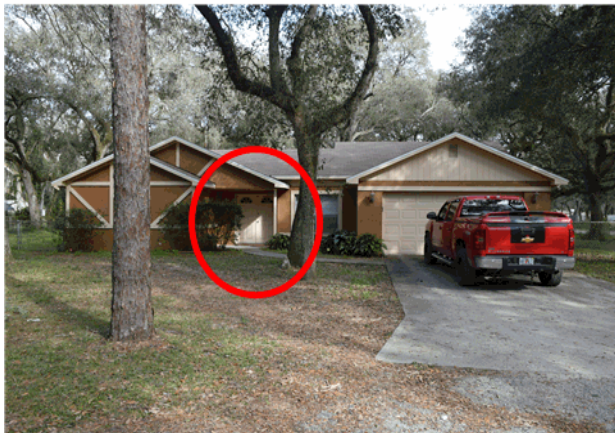
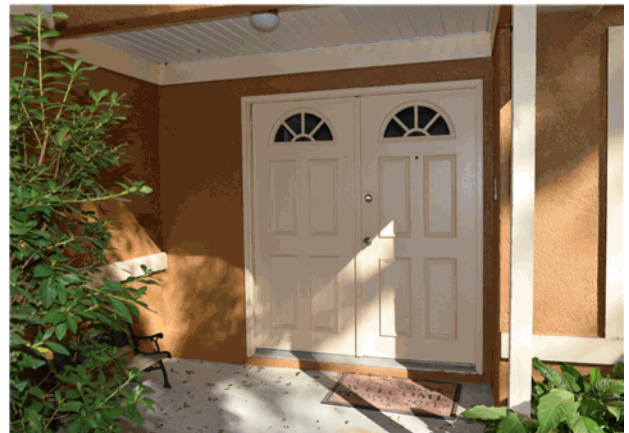
**5) Front Entrance Conditions**

Common settlement type cracks were observed to the porch. The visible and accessible areas of the porch appeared to be in serviceable condition at the time of the inspection.

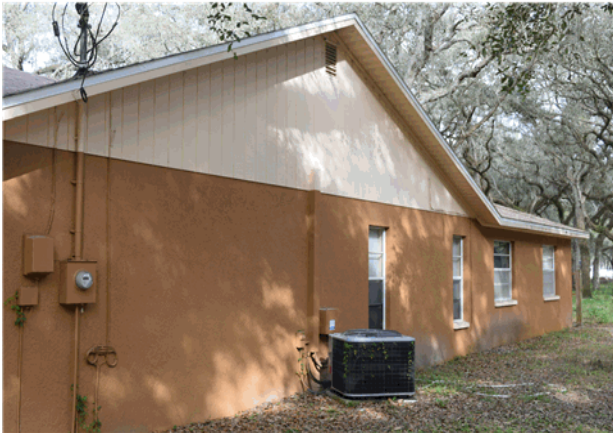
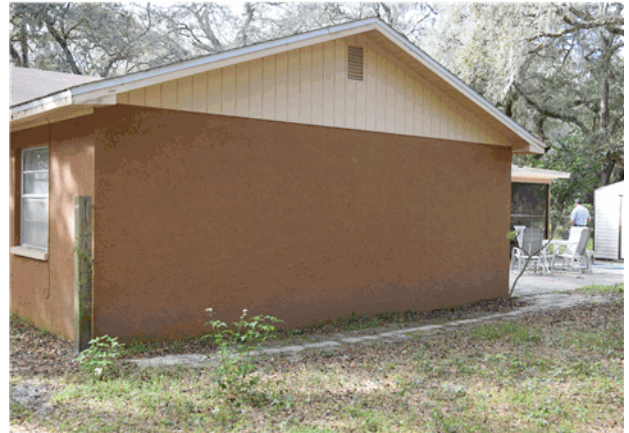
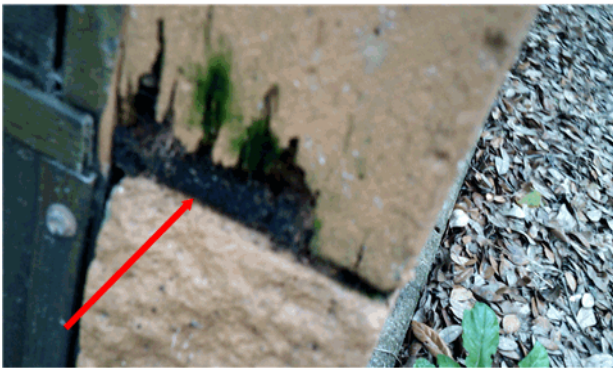
No major cracks found in stucco. House has been recently painted in possibly the past 1-2 years best estimate  
Covered patio post has wood rot. Recommend repair and or maintenance

Patio wood rot on post

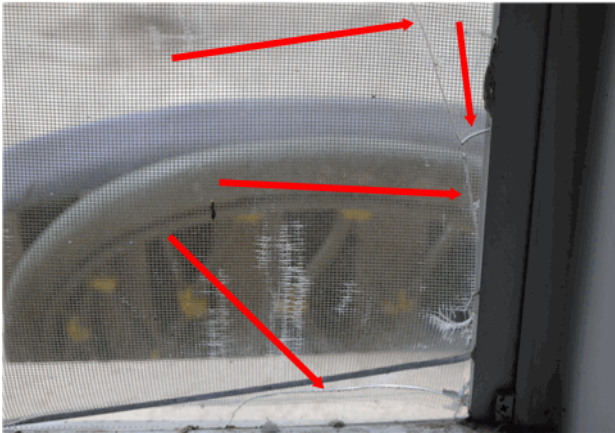
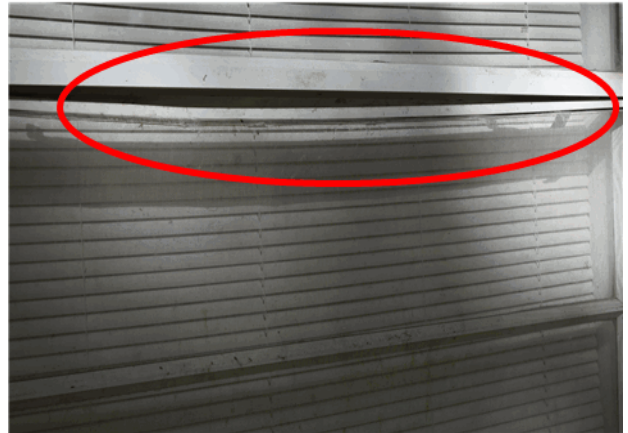
Broken glass pane(s) were observed at 1 window on back of home. Recommend repair as needed. Windows were difficult to open in most cases Recommend maintenance as needed.

Damage Screens on most windows in home

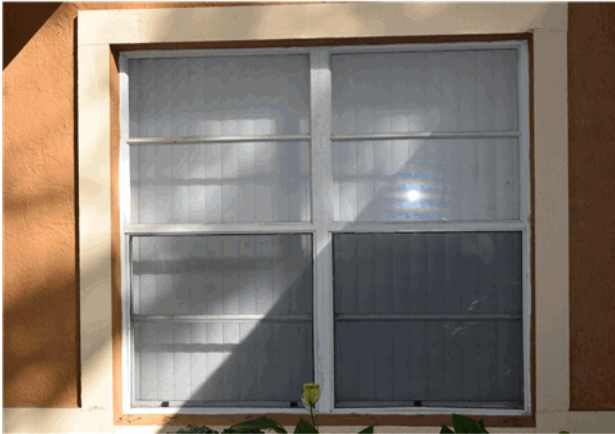
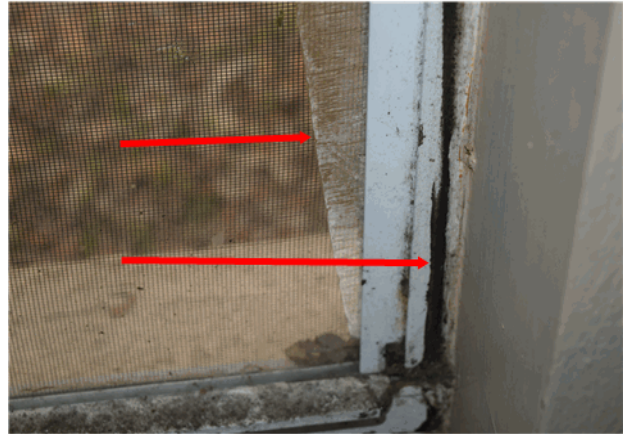
Old Duct tape on window. Possible Mold around window due to possible water leak

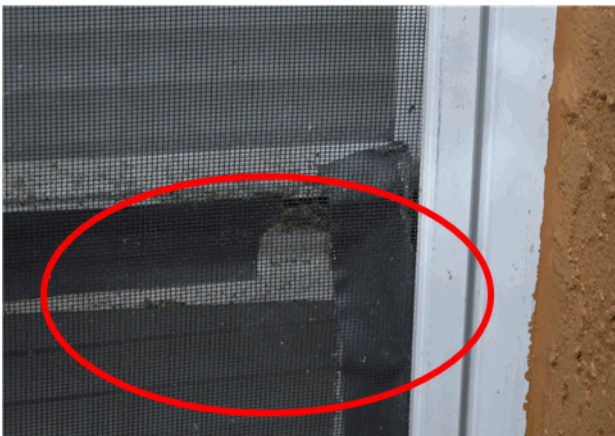
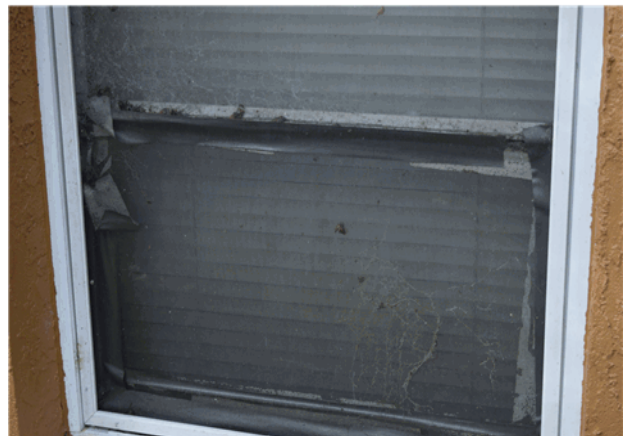
Examples of torn and taped screens

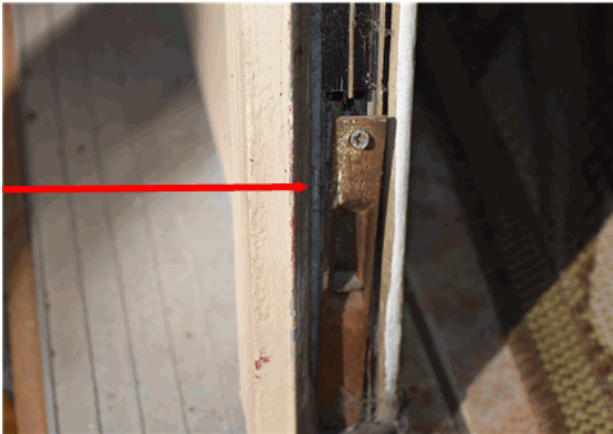
Front door right half locking pins damaged. Unable to lock or unlock properly.

Bottom locking mechanism will not lock or unlock properly

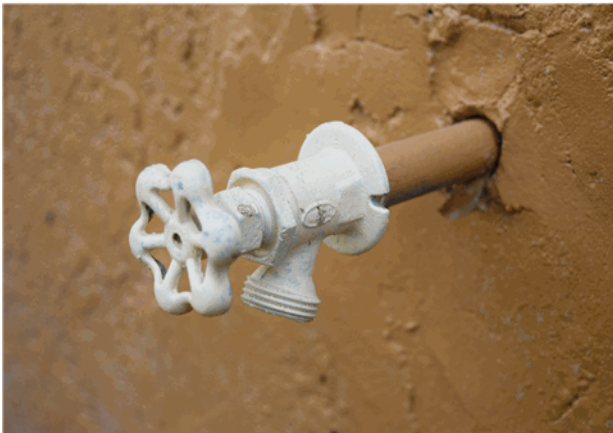
**10) Faucet Conditions**

The hose faucets appeared to be in serviceable condition at the time of the inspection. Would recommend sealant at wall to prevent moisture intrusion

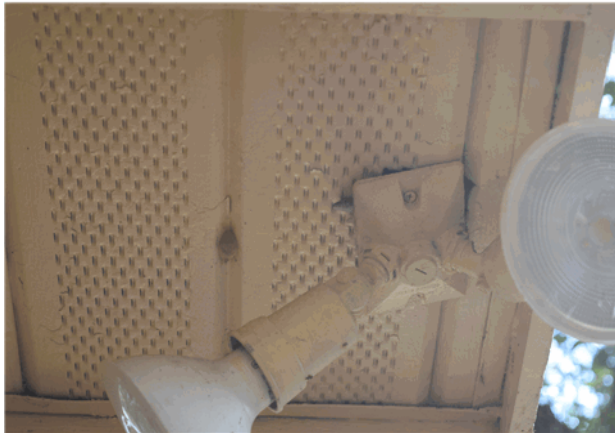
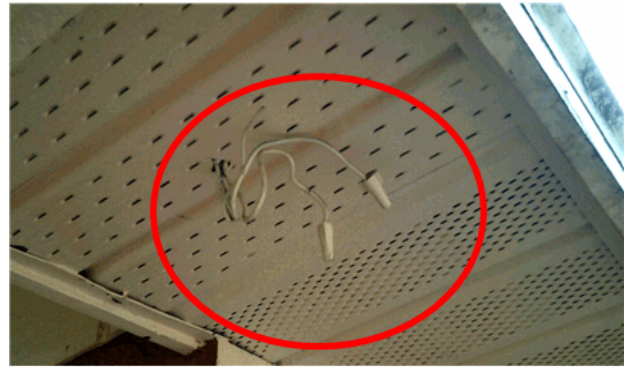
The visible and accessible portions of the chimney(s) appeared to be in serviceable condition at the time of the inspection. Open wires under eave of house on rear corner. Recommend junction box to cover. Recommend maintenance as needed.

Exposed wires on Eave

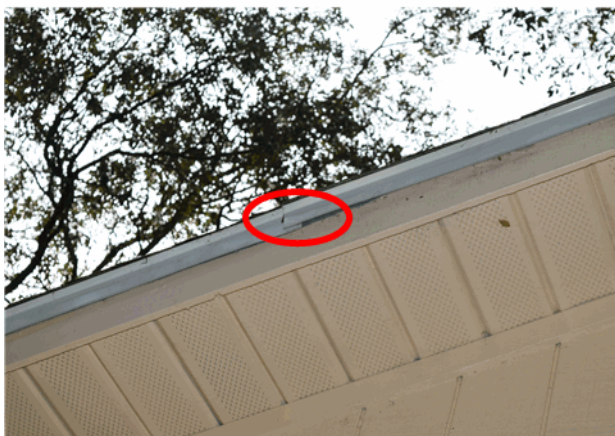
Drip edge not overlapped properly

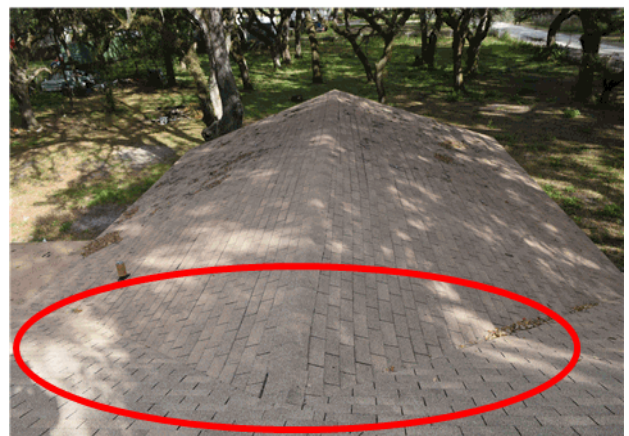
Both Valleys show no sign of being flashed properly

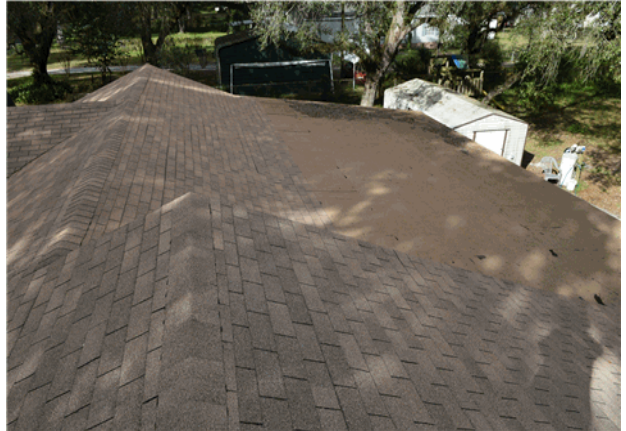
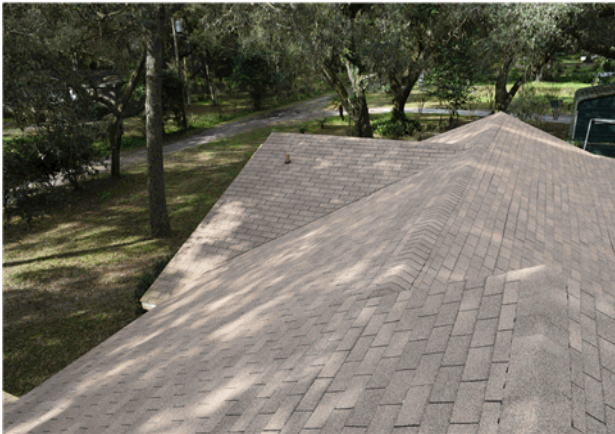
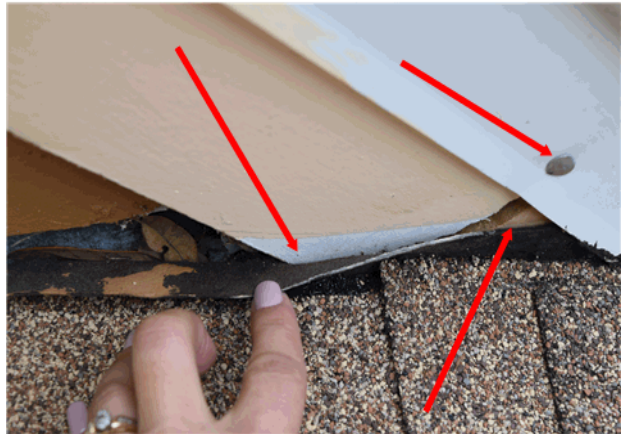
Exposed nail needs sealed. Exposed truss, not flashe properly at gable

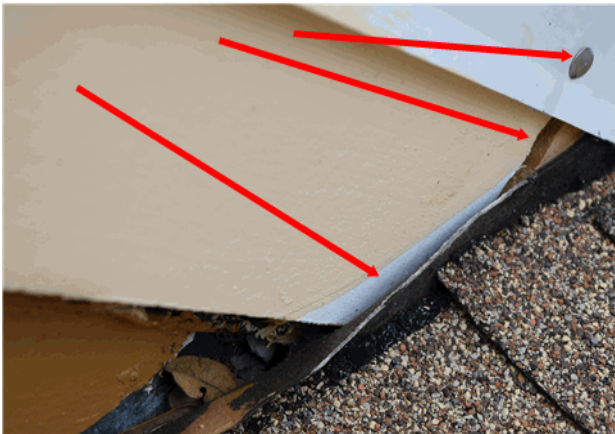
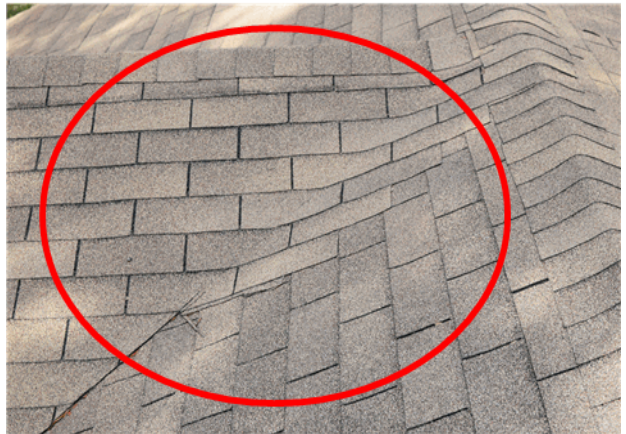
Improper installation.

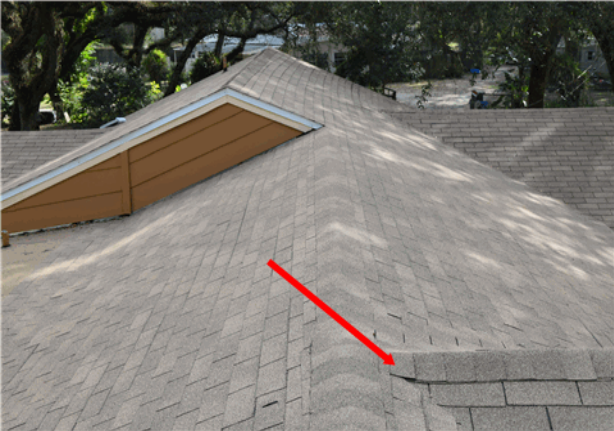
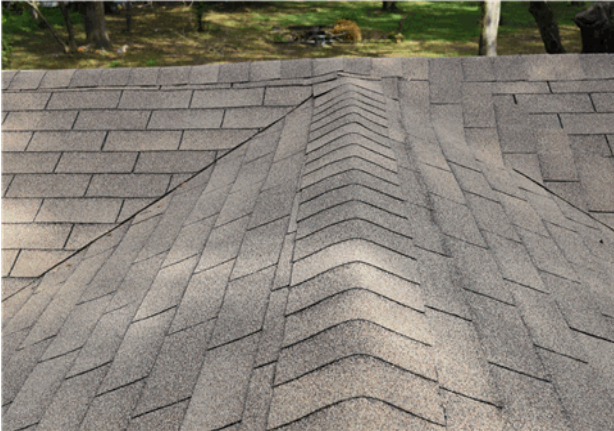
Improper ridge cap install

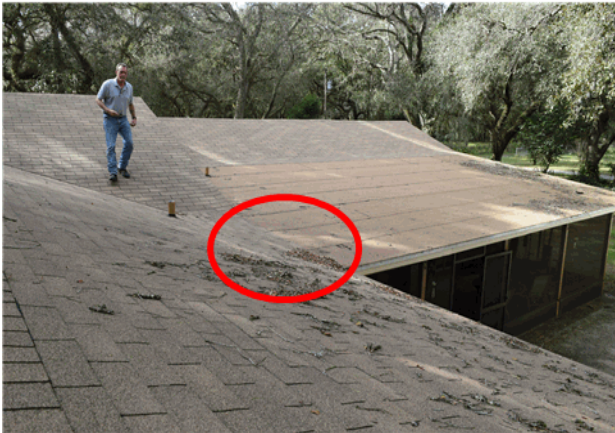
Area circles is less than 1:12 pitch and requires flat roof installation practice. Possible leak pt

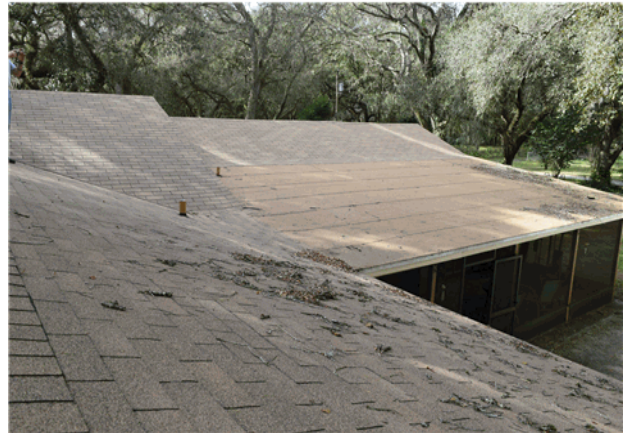
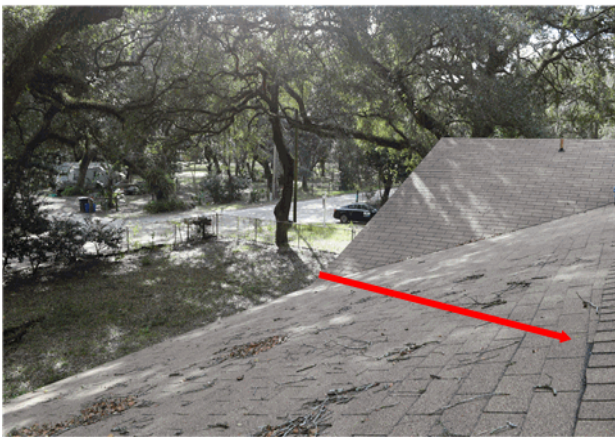
Non professional installation

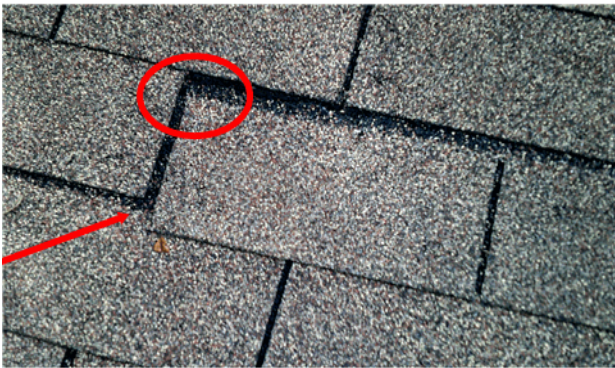
Improper installation

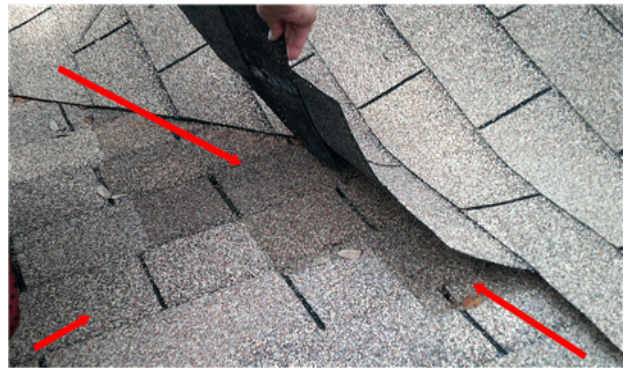
\*\*As you can see from the photos every valley, I was able to lift shingles to expose the runs from opposite slopes. This can allow for water penetration.

Improper Valley install. Picked up shingles.

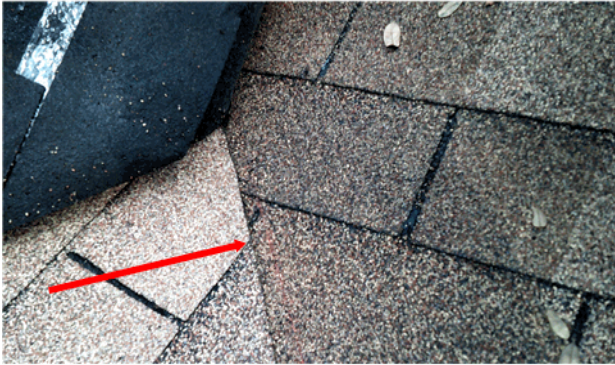
Another bad valley install. Picked up shingles

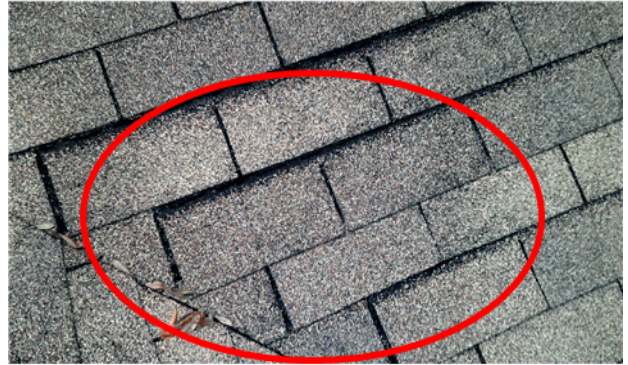
Improper install

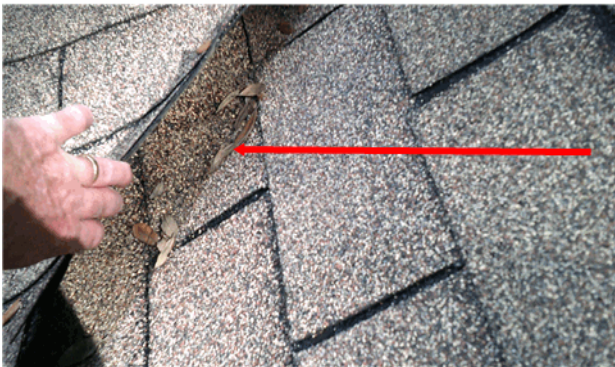
Another valley. Moisture under shingles. possible leak point

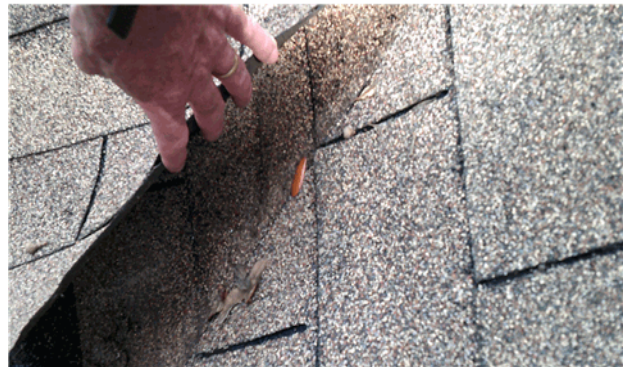
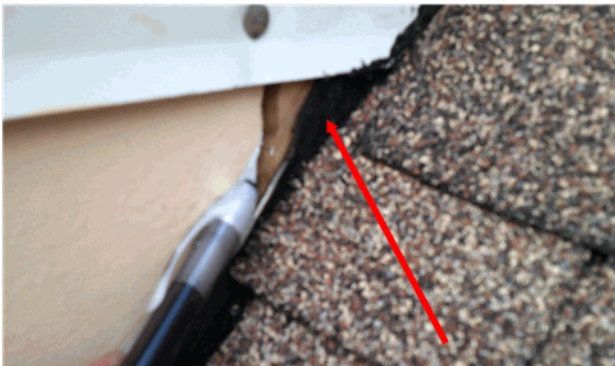
Not flashed. Opening to attic and trusses. Leak point

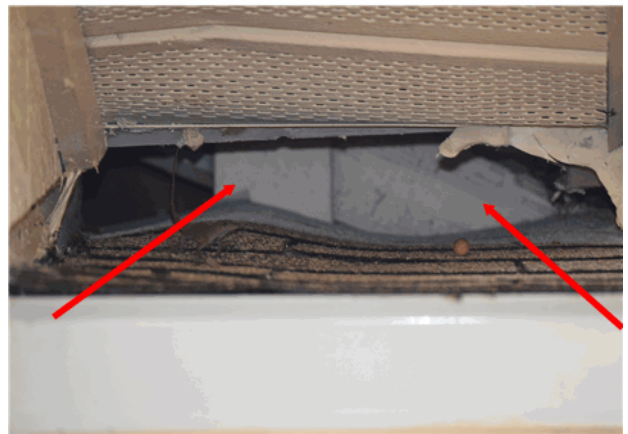
As you enter the home and look to your left you will see a large opening in the roof approximately 5 inches tall by 9 inches wide. This was never enclosed during roof work and you can still see the roof trusses in the attic. This is a potential critter and water intrusion point of entry.

Roof over garage. Critter or moisture intrusion point

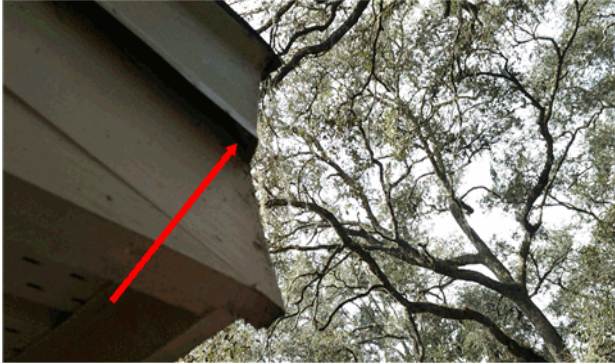
Improper drip edge

time of inspection. Sealing is needed at all vent pipes, chimney, wall and valley seams, and any other through roof projections (including skylights if present) to reduce the possibility of water penetration.

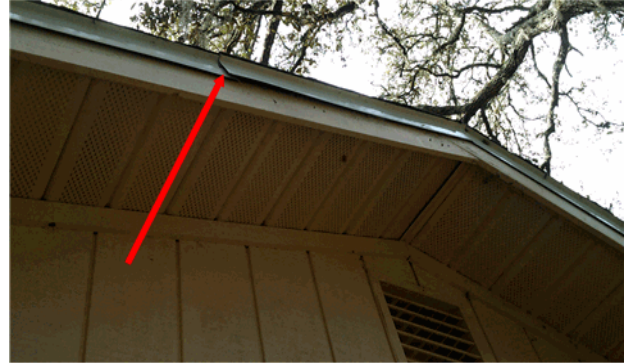
less than 1 inch over lap on drip edge

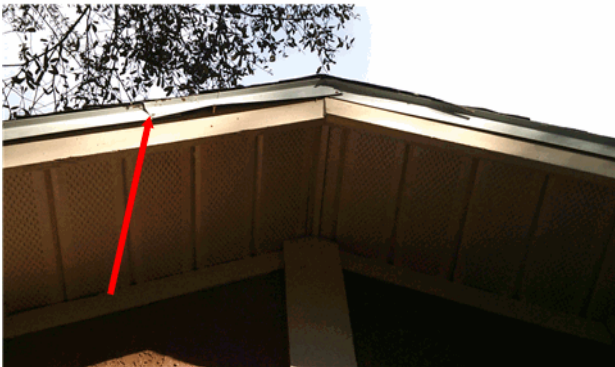
Exposed nail

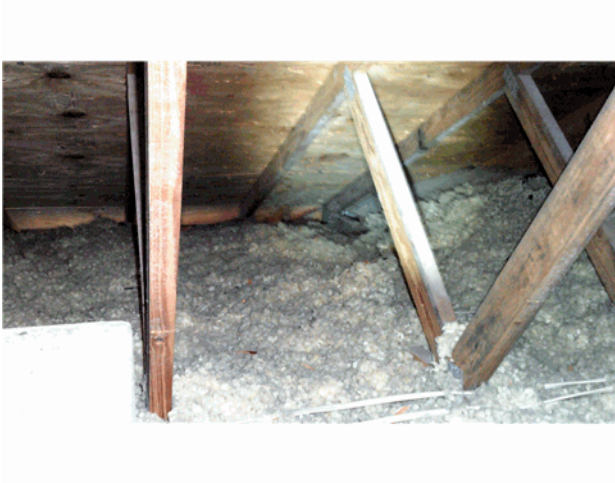
**AS** The visible and accessible portions of the attic appeared to be in serviceable condition at the time of the inspection. Limited ventilation. no ridge vents or stacks. Only 2 gable vents

8 inches of blown insulation

Minimal ventilation was provided to the attic area. This may not be sufficient to move air through the attic properly. Recommend installing additional vents.

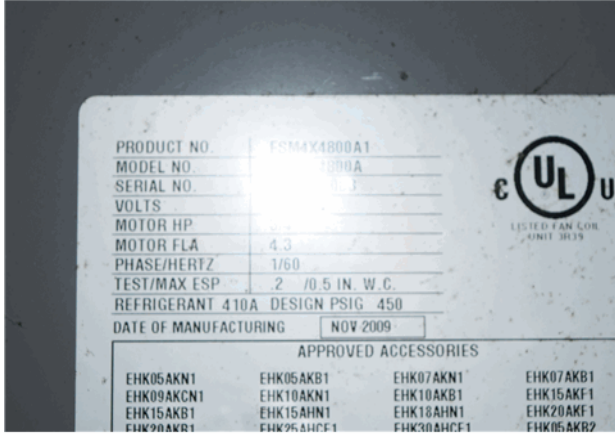
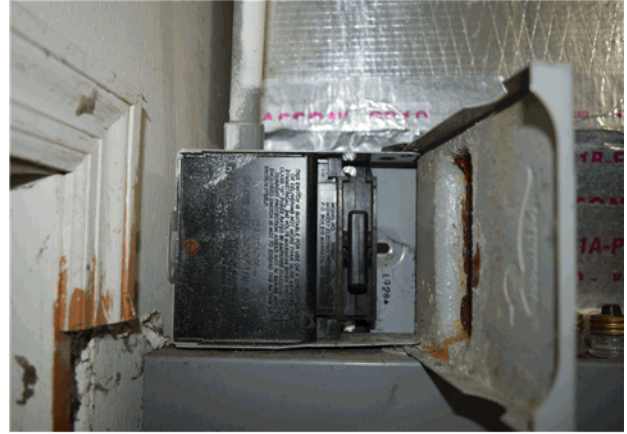
The heating system was operational at time of inspection. This is not an indication of future operation or condition. Air Handler disconnect switch unprofessionally installed. It is suggested that a "Licensed Electrical Contractor" be contacted for further evaluation and repair.

Air Handler disconnect switch.  
Unprofessional install

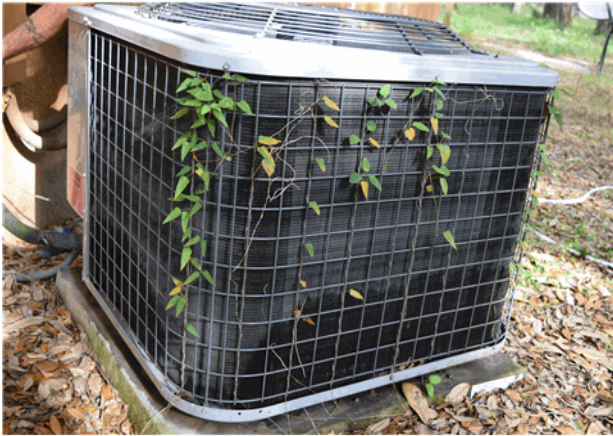
Outside unit has weeds growing in aluminum vents of compressor. Recommend maintenance as needed.

Recomend Maintenance on compressor unit of AC

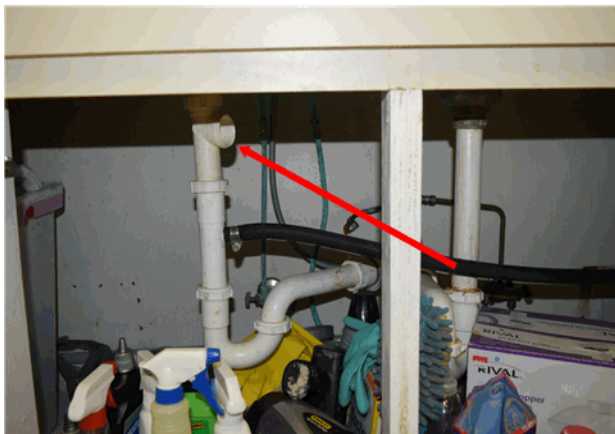
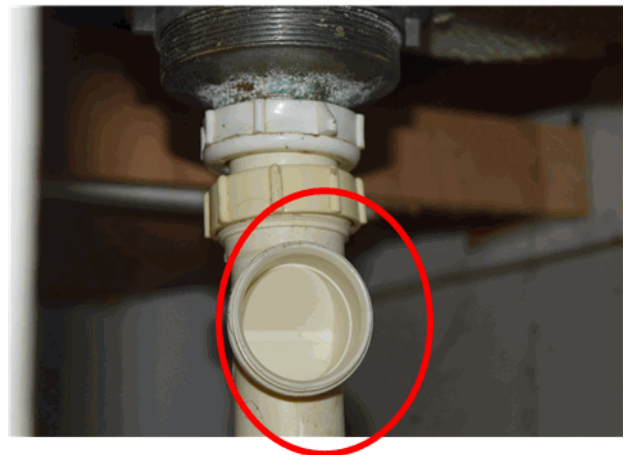
Incorrect drain line installed under kitchen sink. This is a potential point for water leaks from drain in sink.

Wrong downspout from sink.

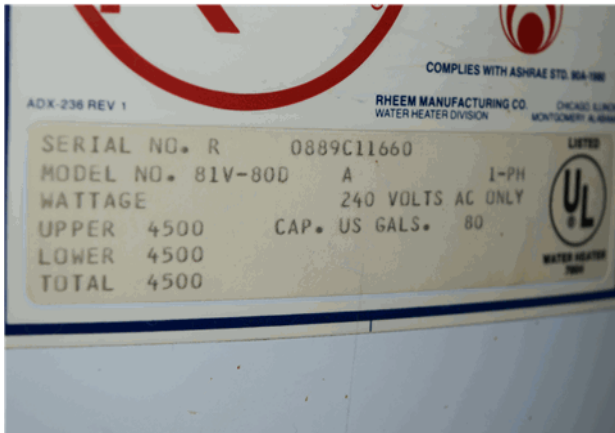
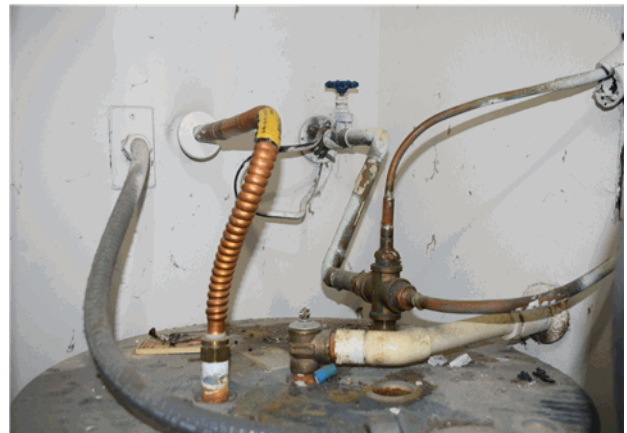
**29) Water Heater Conditions**

The water heater was operable at the time of inspection. This does not however guarantee future performance, operation, or condition. Age Unknown. Blocked by personal items

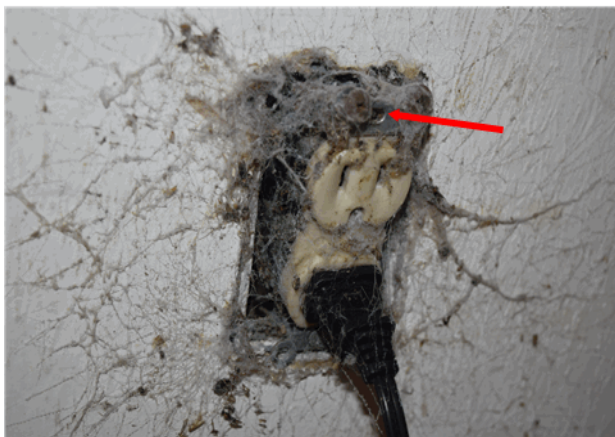
lug in living room no cover and not secured into wall

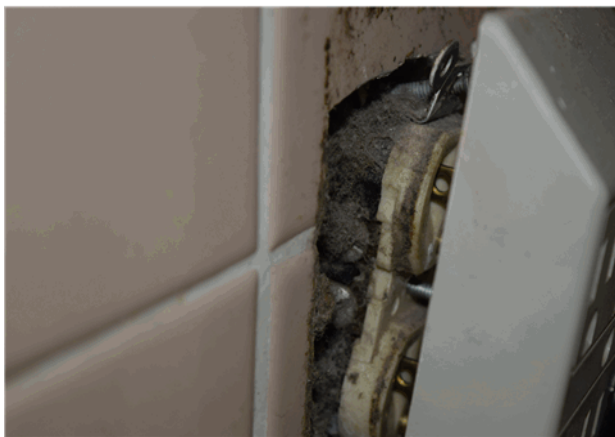
2. The kitchen only contains one GFCI outlet. This outlet is not tied in with any other outlets. This is a potential safety hazard and should be evaluated further by a licensed electrician.

49) Electrical Conditions R No GFCI's installed in kitchen or in breaker panel in garage.It is suggested that a "Licensed Electrical Contractor" be contacted for further evaluation and repair.

Kitchen outlet pulled out of wall

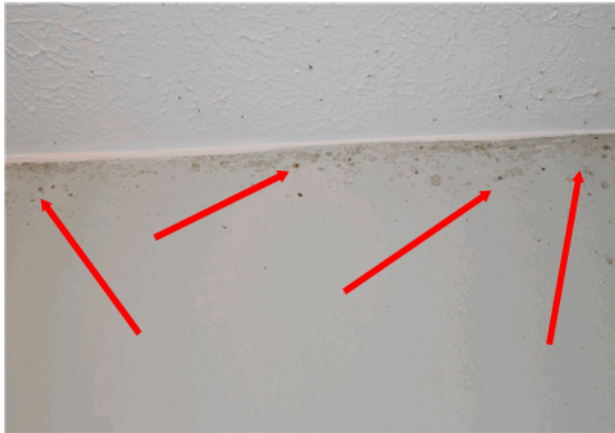
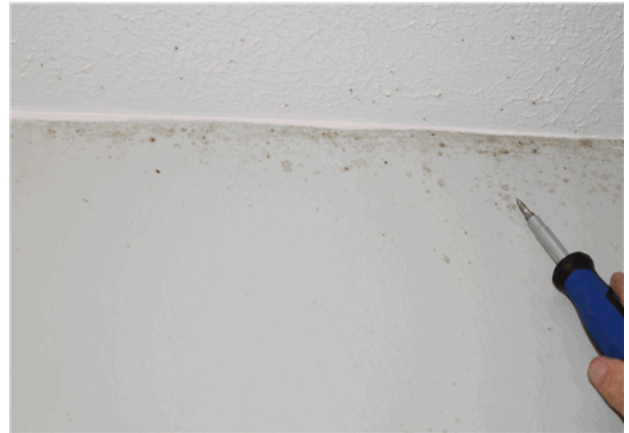
3. There is evidence of mold growing on the exterior wall inside the hall bathroom. This may be caused by a potential leak from where the roof valleys meet. Recommend further evaluation by a roofing contractor.

59) Wall Conditions AS Hall Bath found evidence of Mold possibly from roof. Recommend maintenance as needed.

Mold evidence. Ceiling has been recently painted

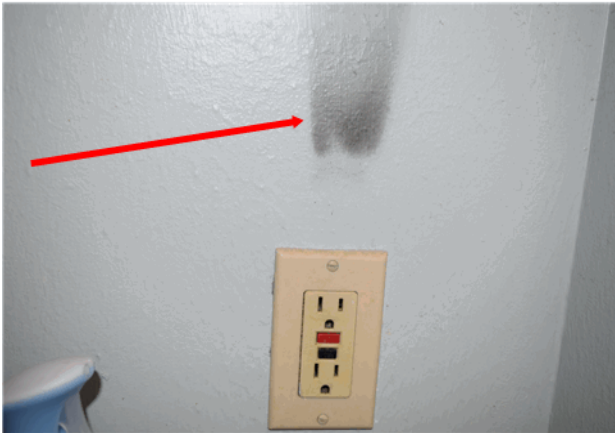
Hall bath GFCI is not in working condition and there are signs of scorching above outlet. Recommend a licensed electrician further evaluates this possible safety issue.

GFCI in hall bath does not work. Scorching above outlet. It is suggested that a "Licensed Electrical Contractor" be contacted for further evaluation and repair.

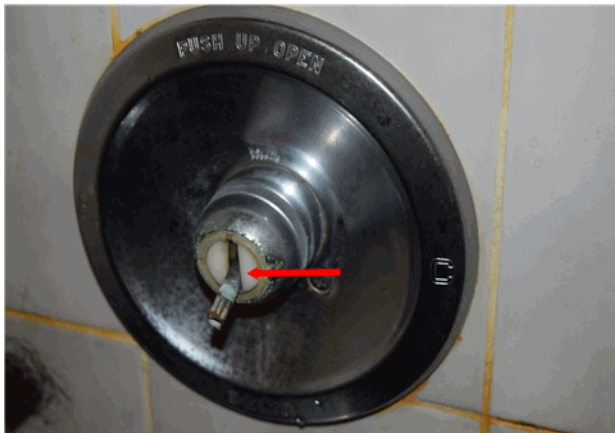
70) Shower - Tub Conditions AS Shower/bathtub water faucet falls off Recommend maintenance as needed.

Handle Falls off

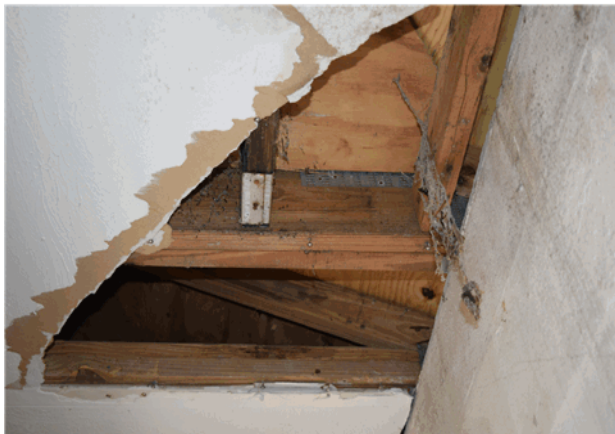
**73) Ceiling Conditions**

Hole in ceiling. Possibly from previous water damage

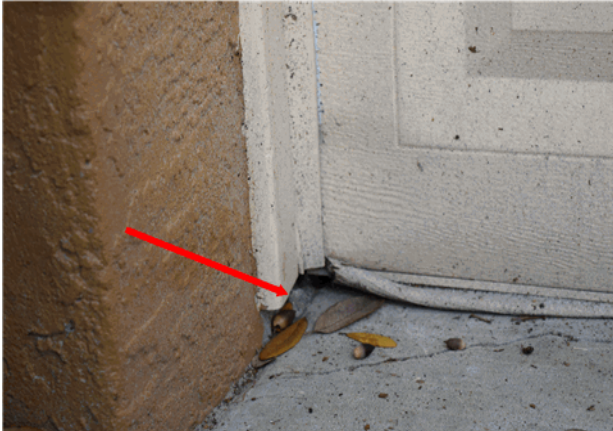
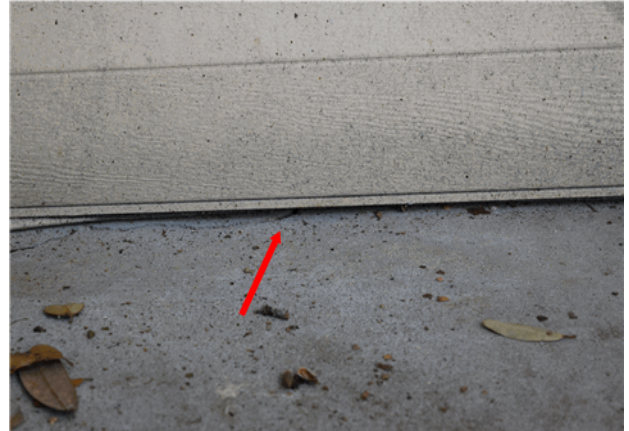
Seals around door worn. Recommend maintenance as needed. The vehicle door(s) appeared to be in serviceable condition at the time of the inspection.

Seals around door worn
